HANFORD SITE LOW EXPOSURE PIPELINE REPAIR USING A NON- METALLIC COMPOSITE SYSTEM

R. J. Huth
CH2M HILL Plateau Remediation Company

Date Published
November 2009

**HANFORD SITE LOW EXPOSURE PIPELINE REPAIR
USING A NON-METALLIC COMPOSITE SYSTEM - 10154**

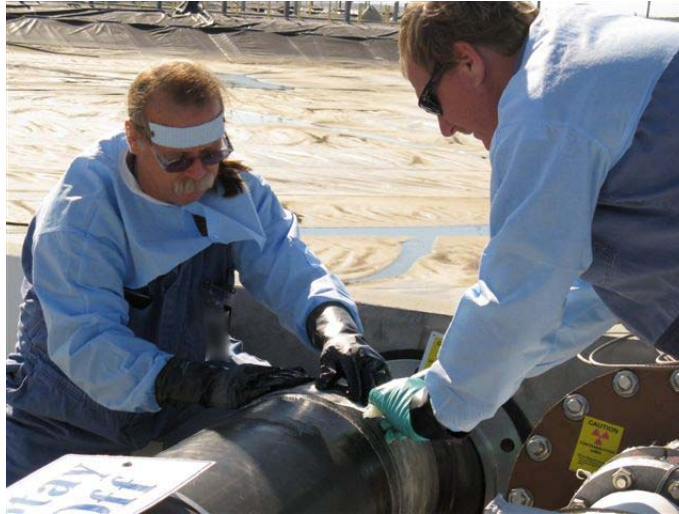
Fig. 2 – Application of epoxy impregnated base matrix to HDPE elbow

The pipe was primed with a “Standard Matrix” epoxy for a distance of 10 to 13 cm (4 to 5 inches) on either side of the failed bond, and 14 meters (45 feet) (about three layers) of the epoxy impregnated base matrix was wrapped tightly around the pipe joint. A temporary band of plastic wrap was applied around the installed base matrix during curing. This plastic wrap aids in adhesion by compressing the fabric matrix against the HDPE pipe, and helps form a smooth exterior finish. After the base matrix was fully cured, the plastic wrap was removed, and the matrix was lightly sanded and buffed to remove any sharp edges.

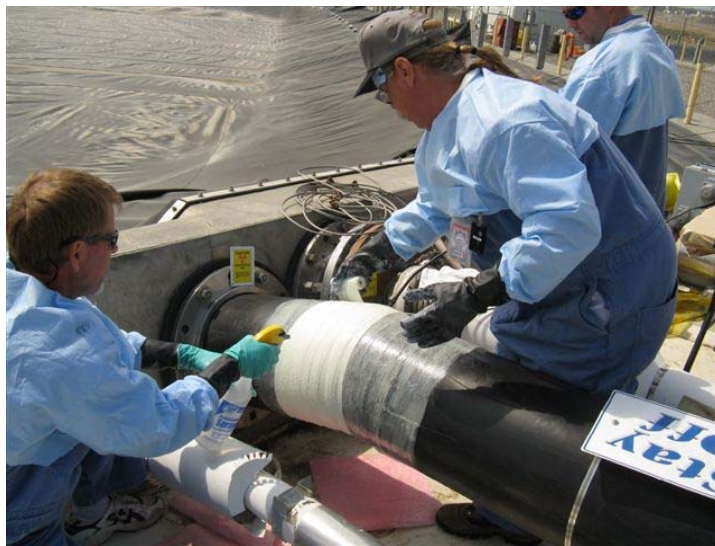
Fig 3 – Application of final layer as water activated fabric is wetted

In preparation for the application of the wetted final layer, a specific primer was applied to the repair area out to about 30 cm (one foot) past the base matrix wrapped area on each side. The water-activated fabric was wetted and wrapped over and beyond the base matrix, four layers thick.

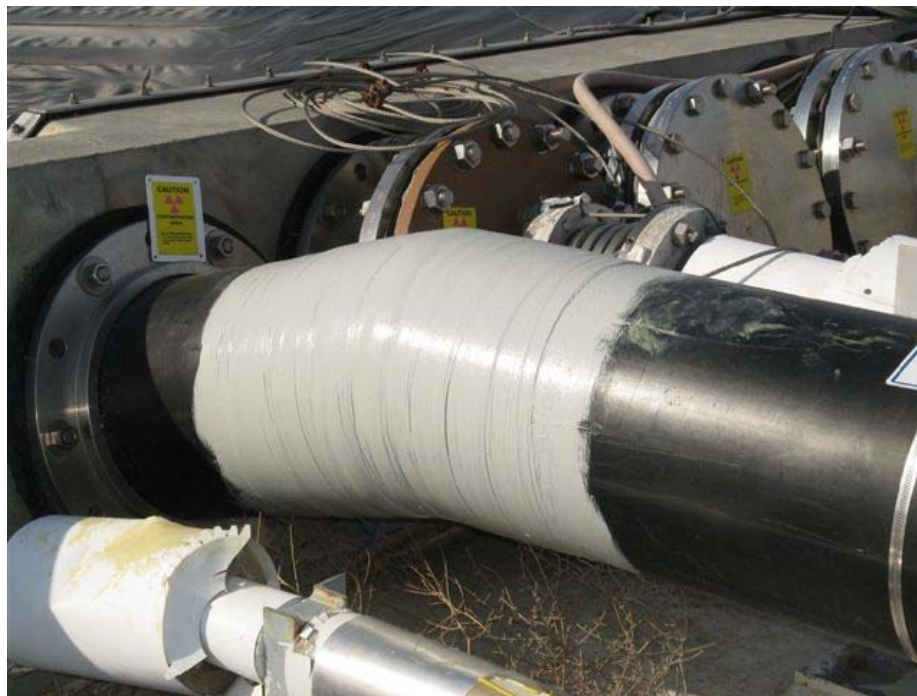
Fig. 4 – Final repair after paint coating

Plastic wrap was again used, and removed after curing, about 24 hours later. Rough areas were sanded smooth, and a final compatible paint coating was applied over the entire area, as a protection against damage from UV. An initial service leak test was successfully performed and the recirculation line was returned to service in June of 2009.

In addition to applying a coating for UV protection, the repaired area was covered with ceramic fiber blanket insulation for additional UV protection. “Stay Off” signs have been placed on the piping to limit “personnel” loading on the line. Four times a year, the insulation will be removed and a formal inspection for signs of failure or leakage will be performed.
